RICHARD L. MEEHAN

Re: Dairi Prima Minerals (DPM) Mine site risks and Tailings disposal safety. Review of Dairi April 2021 EIA Addendum.

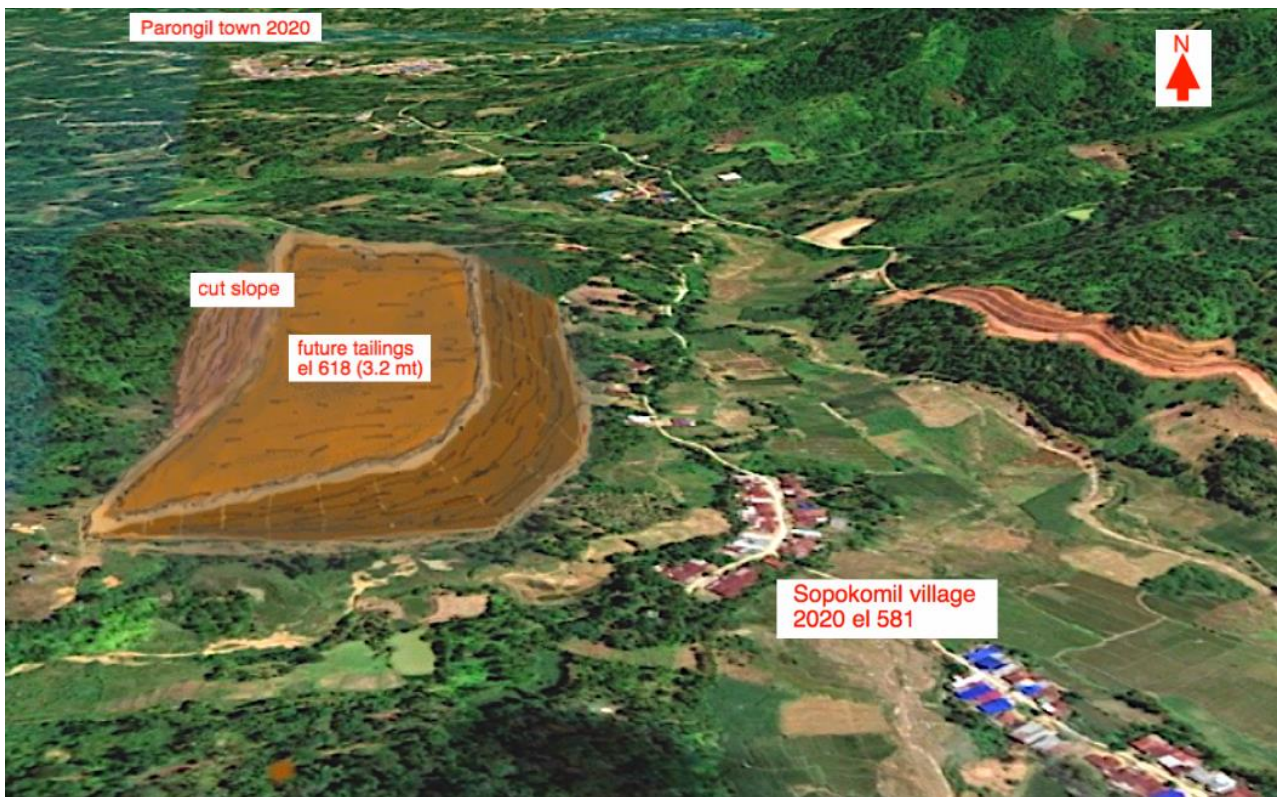
Figure 1. Planned configuration of TSF, 3.2 million tons at elevation 618. TSF configuration (brown color) from EIA Addendum fig 2.22 sketched onto Google Earth image by the author. Breach of the tailings dam above the Sopokomil village is likely in a strong earthquake because the ground between and beneath the village and the TSF and the dam foundation is unstable volcanic ash soils subject to liquefaction and landsliding.

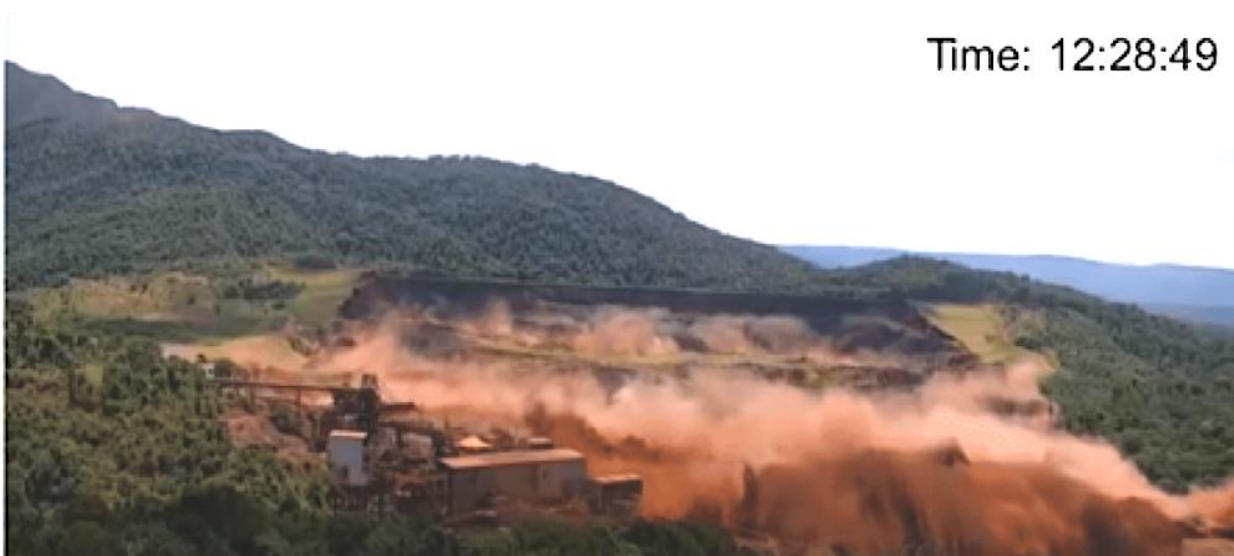
Figure 2 Brumindinho TSF failure 2018

The best known tailings failure of our times is the Brumindinho failure in Brazil in 2018. This has been discussed in my previous reports. The photos shown here are during the course of the failure and show the entire containment “wall” of the tailings failing simultaneously. The containment, or a dam wall, in this case was of the dangerous design that was used traditionally in TSF facilities but has a record of high frequency of failure. It consisted of no more than a thin shell of small dikes holding back a large lake of easily liquefied tailings. Failure has occurred with these designs either spontaneously or after even a moderate wet season.

The type of construction used at the Brumindinho TSF, the so-called “upstream method”, is no longer accepted in most places today because of its high danger of failure even without an earthquake. The DPM TSF proposes using a sturdier rock fill dam wall to retain the tailings. However, whatever the strength of the dam wall might be (even if it is massive concrete), if it rests on unstable foundations, it will fail by sinking, spreading or sliding, with either overtopping of the sunken dam wall or a local space breach that then enlarges and may substantially empty the TSF with discharge to the lands below. A structure built on a failing foundation will not stand.

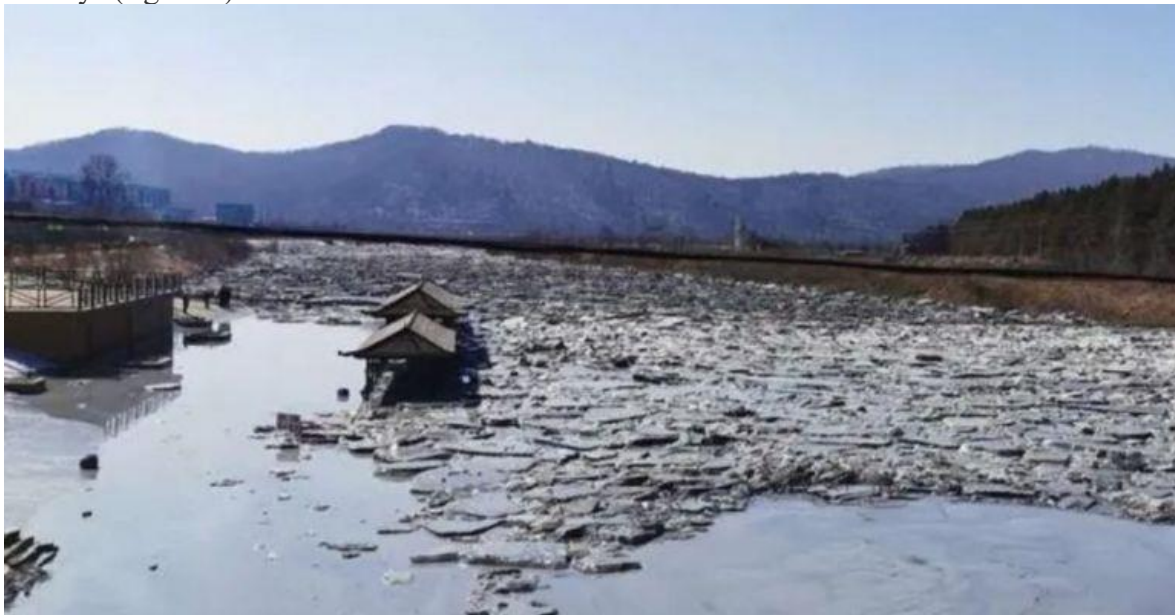
(2) failure of elements of temporary or permanent underground drainage such as occurred at the Chinese molybdenum tailings dam last year and sent toxic materials some 123 km downstream of the facility⁶ (figure 3)

Figure 3 An unstable foundation may also lead to a TSF spill that would not necessarily destroy villages, but rather flood downstream streams with toxic waste as here last year at China's Yichun Luming TSF.

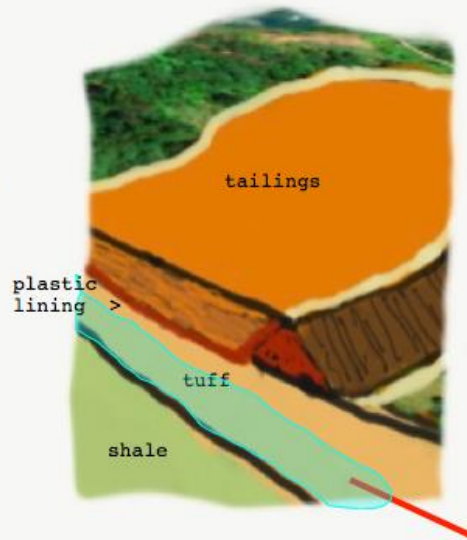
In the TSF infrastructure plan area, the lithology is dominated by Toba Tuff which has a thickness of up to 50 m. Several monitoring wells, such as AT-6 and AT-10, were formed in the same Toba Tuff rock unit. Toba Tuff in terms of hydrogeological parameters is included in the level of moderate to high water porosity.

The potential for landslides in the mine plan area is caused by:
1) Medium to high rainfall in the mine area ranges from 1,500 mm / year in TSF area.

2) Lithology: geological conditions, the presence of tuff rock in the TSF area has the potential for landslides due to the physical properties of the rock itself with high porosity so that it has the potential to become an aquifer. The tuff rock is deposited in the impermeable rock layer (shale) so that when the aquifer becomes saturated it has the potential for landslides.

Figure 4 Potential landslide with saturation of the Toba tuff

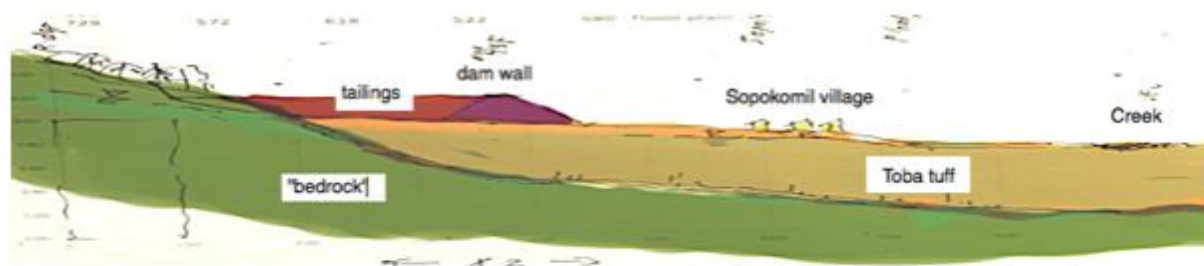
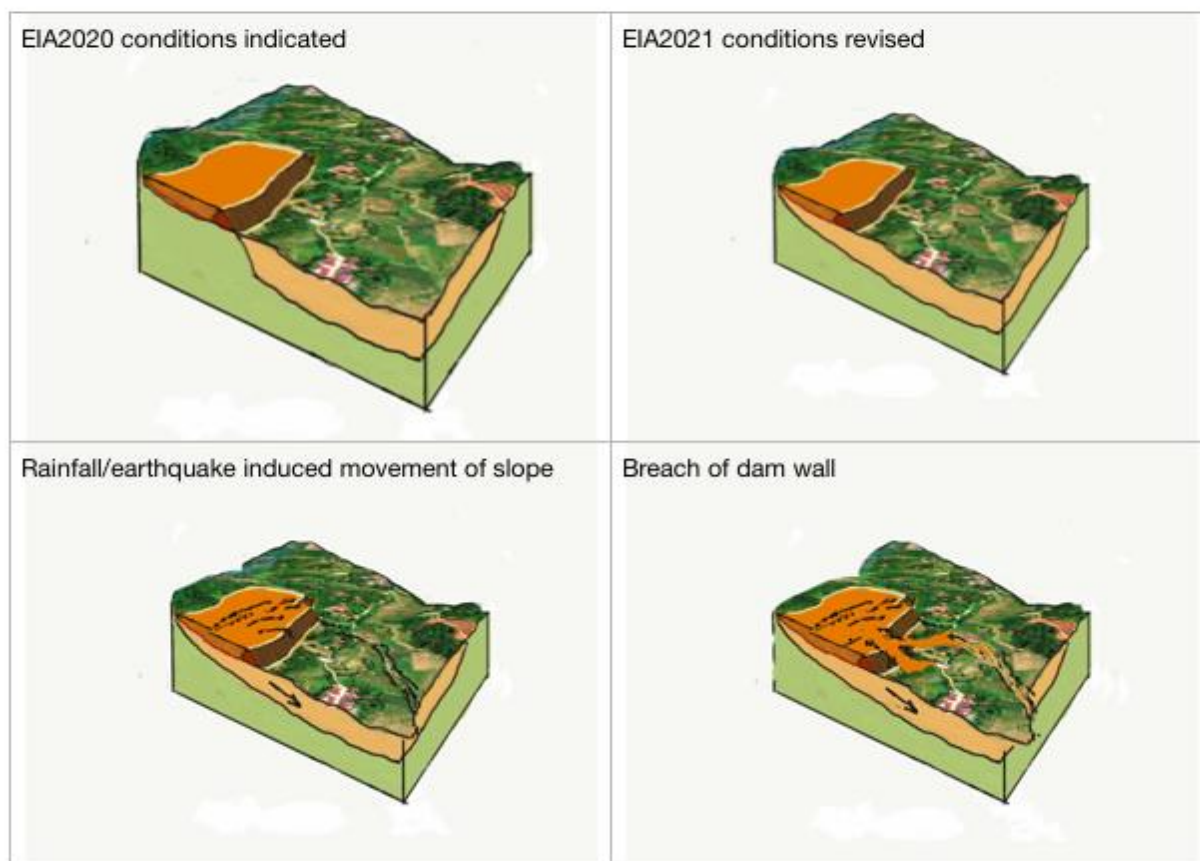
The scenario I have in mind is illustrated on the sequence of images on figure 3 and figure 4. Basically, the whole slope on which the TSF is located could move downslope under the weight of the TSF (indeed, Toba tuff has seen similar landslides (see Appendix A) even without loading associated with a TSF). The lower bound of sliding may be within in the Toba tuff layer or at zones of weakness and high pore pressure at the base of the tuff. With such a movement it is difficult to believe that the proposed TSF would not fail, either collapse or by rupture of linings.

Figure 5 Cross section as verified EIA2021 with likely ground failure scenario brought on by rain and earthquake

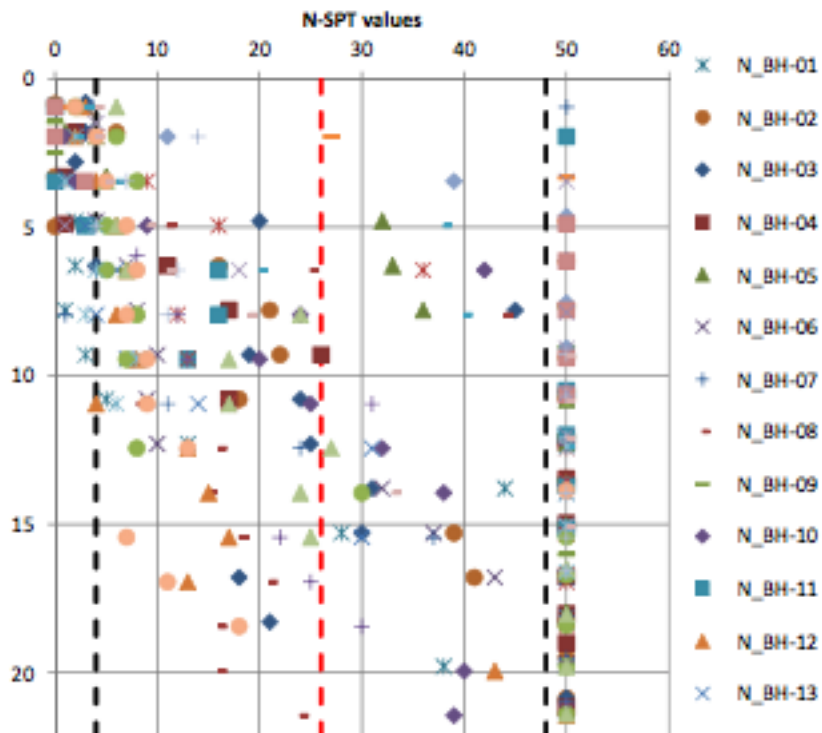
A proposed geothermal plant, the Sarulla project also in the Toba tuff involved recent site explorations which are documented as showing unwelded Toba tuff as being in a loose condition (Standard penetration test N values less than 10) with potential earthquake liquefaction potential in the upper 10-30 meters.

Figure 10 Standard penetration tests in Toba tuff at Sarulla geothermal plant.

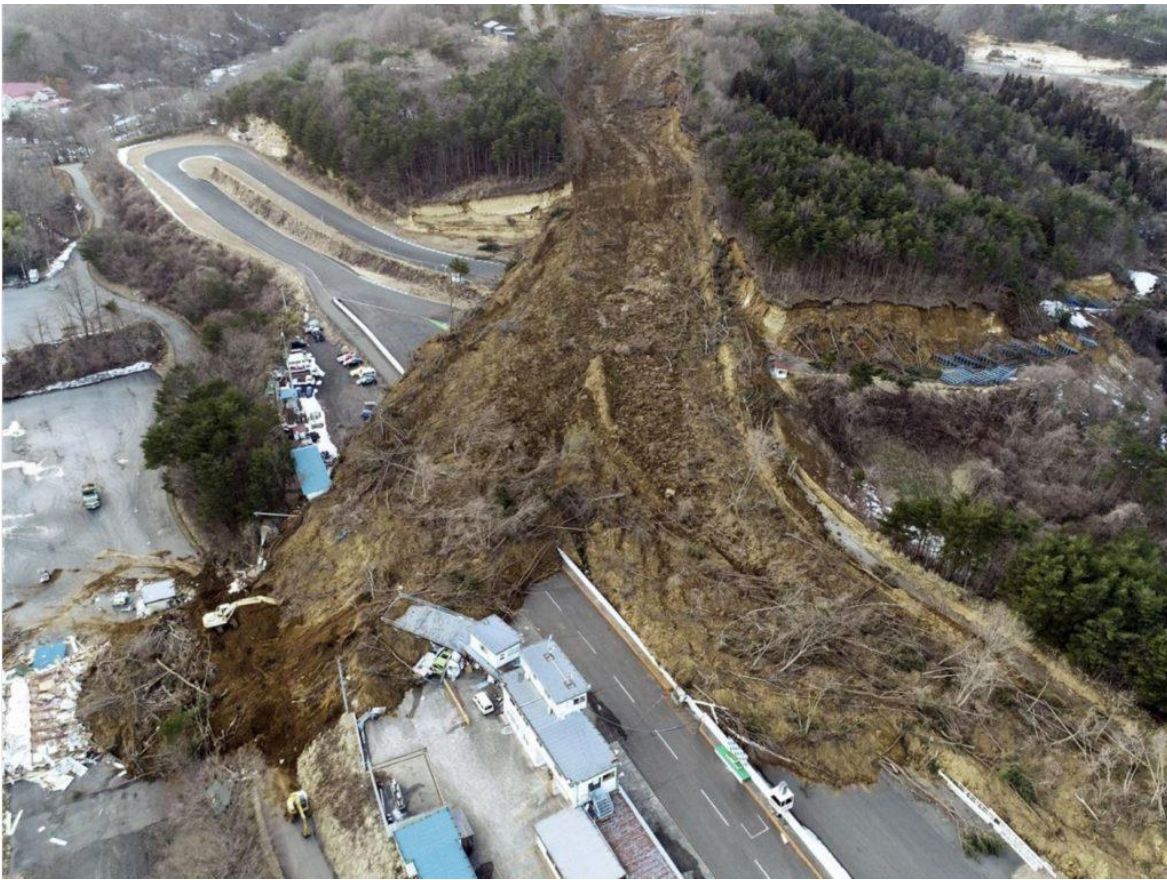
Figure 11 ash landsliding in Japan 2020, combination rain and earthquake.

The susceptibility of volcanic ash is well known in many areas of the world where such deposits are present. Japan also features volcanic ash and as recently as June 2020 landsliding occurred in figure 11 with notes by the observing geologist that volcanic soils are particularly dangerous

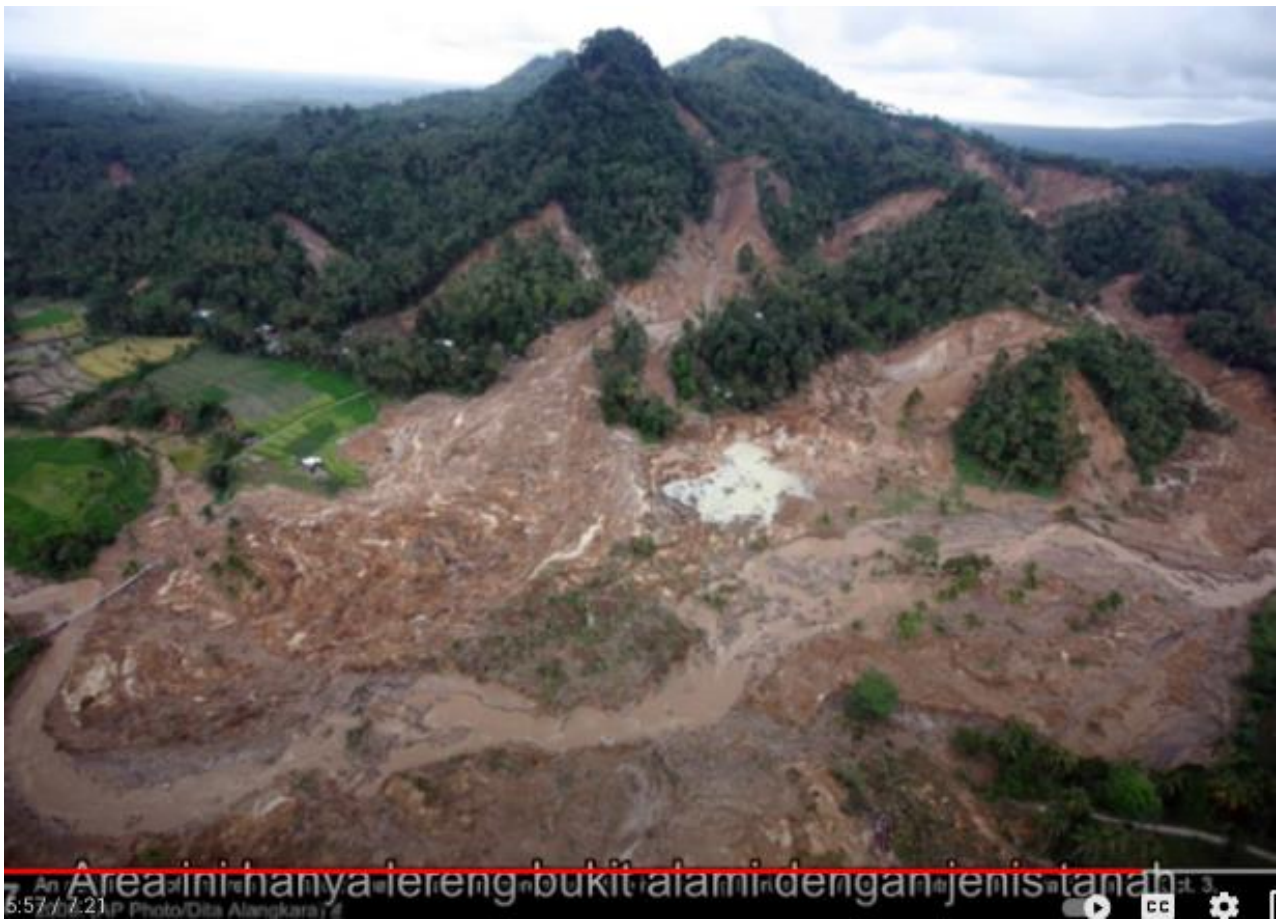
Landsliding in rain saturated Toba tuff slopes in Sumatra has led to many fatalities. The character of the Toba tuff and its contact with underlying bedrock are described in Gratchev 2020¹²

Figure 12: 2009 fatal landslide at Parmina following heavy rain and earthquake
