**RICHARD L. MEEHAN**

June 16, 2023

Re: Dairi Prima Minerals (DPM) Mine site risks and Tailings disposal safety.  
Review of Dairi 2022 EIA Addendum.

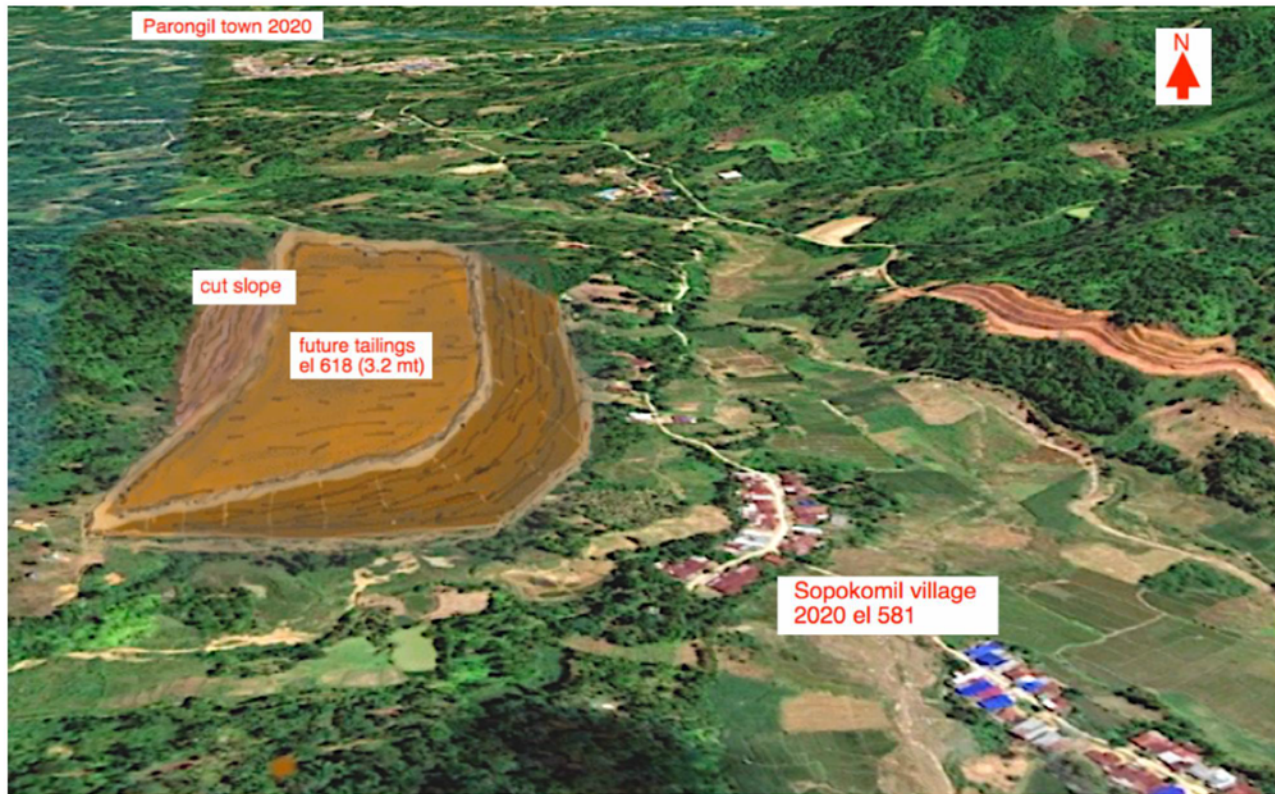
*Figure 1. Planned configuration of TSF, 3.2 million tons at elevation 618. TSF configuration (brown color) from EIA Addendum fig 2.22 sketched onto Google Earth image by the author. Breach of the tailings dam above the Sopokomil village is likely in a strong earthquake because the ground between and beneath the village and the TSF and the dam foundation is unstable volcanic ash soils subject to liquefaction.*

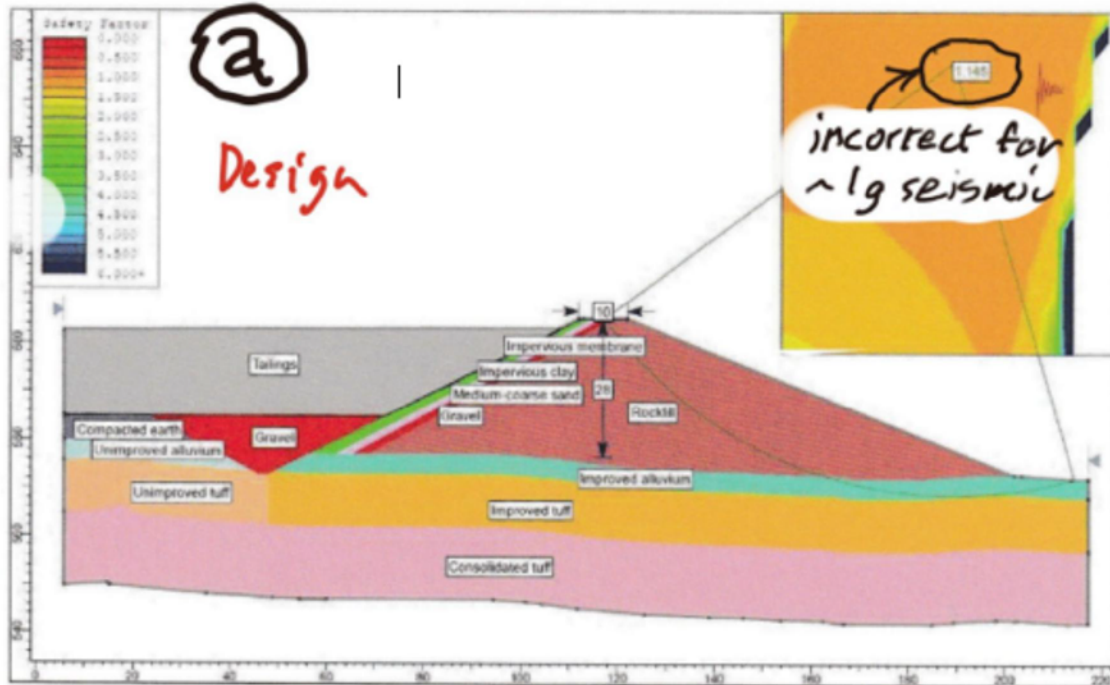
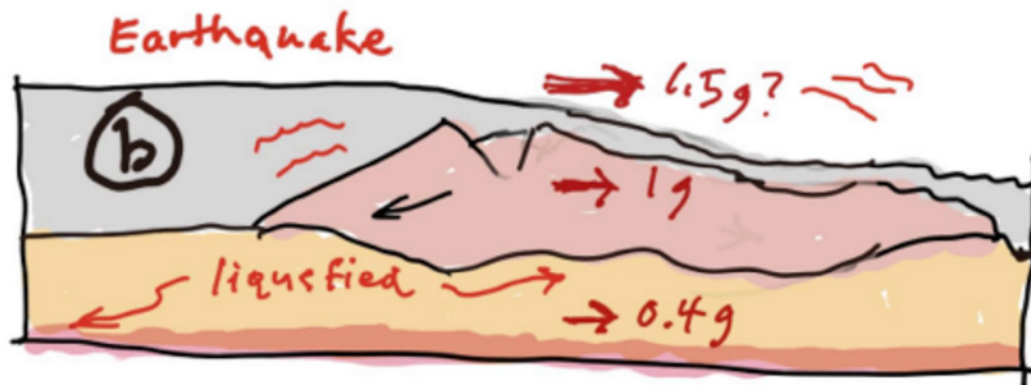
Gambar 2.47 Gambar Perhitungan Nilai FoS Disesuaikan Dengan Kondisi Akhir TSF

This amplification in the material overlaying the bedrock would invalidate the undocumented seismic stability analysis provided by DPM in EIA Figure 2.47. That figure concludes that the “factor of safety” (which must be more than 1.0), will be 1.03 apparently for Prof Natawidjaja's "maximum credible" earthquake of .489g. However, if site amplification is taken into consideration, the “factor of safety” for DPM’s proposed TSF would be below 1.0, down to even 0.7 (meaning the dam would be considered highly unsafe). Even lower factors of safety would occur if the dam and tailings quantities were higher than that specified in the EIA. Emerman(2023) has conducted a study of surface storage requirements for the TSF and concluded that the EIA significantly underestimates the volume and height of the required TSF. If this proves to be the case, even lower margins of safety will result.

In addition to lowering the factor of safety, failure to consider amplification also results in an incorrect failure configuration such as the one shown on EIA figure 2.47, part A. Amplified ground motion or loss of foundation bearing capacity due to liquefaction would instead flatten the failure surface in a way that causes sinking of the dam as suggested in the sketch, part B herewith.

DPM now claims, without any stated basis, (figure 2.47, extract attached) that unstable ash soil does not extend to depths greater than 16 meters. It may extend deeper, but even 16 m depth, over an area of roughly 100 x 500 m represents 800,000 cubic meters (more than a million tons) of soft volcanic soil that would need to be “improved”. This is more than the volume of the retaining rock fill dam. Removal, replacement, compaction or other form of stabilization of this amount of soil would be in an enormous task and unlikely to be implemented because it would make the project economically infeasible. There is not even any suggestion as to whether this ash *can* be improved by normal recompressive efforts, addition of chemicals, etc. In fact, the EIA Addendum elsewhere indicates that the ash is not suitable for important construction except for road fill because it is “soft volcanic eruption”.
