RICHARD L. MEEHAN

Consulting Engineer  
50 years • Dam Safety • Engineering Seismology.  
Tropical Geotechnical Engineering  
meehan@stanford.edu

**Re: Dairi Prima Minerals (DPM) Mine site risks and Tailings disposal safety.**

**Summary:** Based on information available, and without a site visit, I provide comment on tailings dam stability risks associated with the Dairi Prima Minerals (DPM) mine in Dairi Regency, North Sumatra.

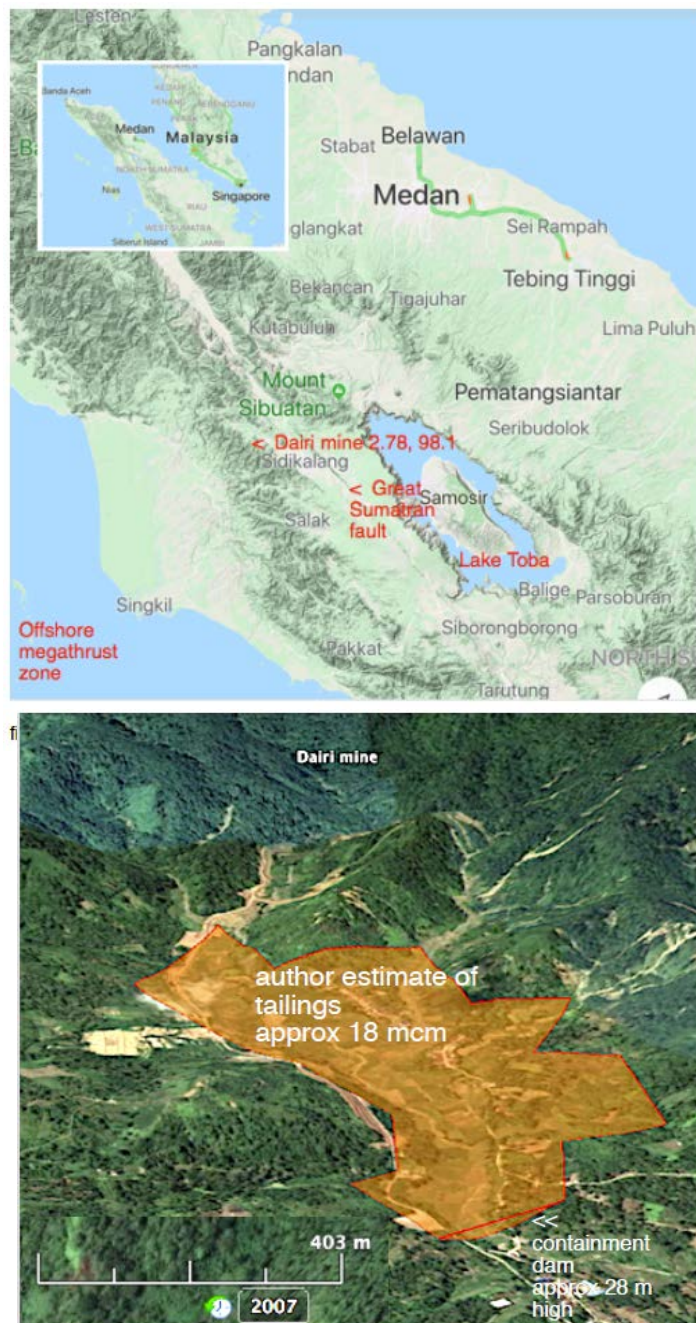
Figure 2. View of author's estimate of tailings

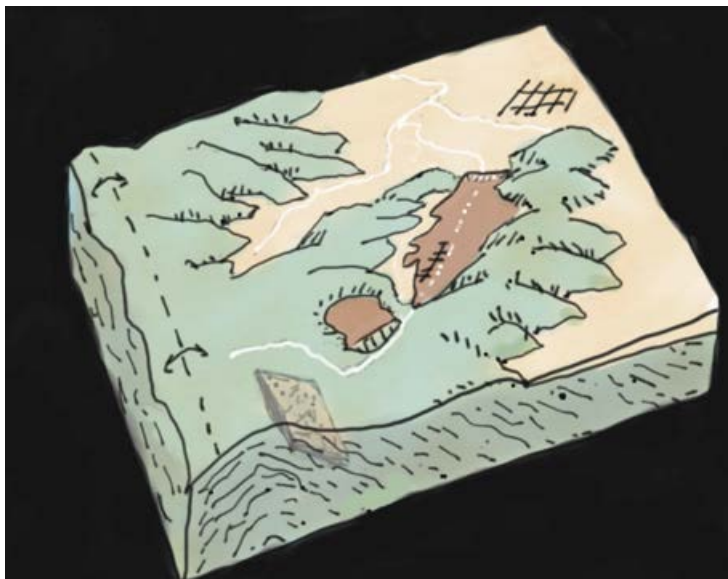
*Figure 3a Sketch of general geological features and reported alternate tailings dam disposal areas.*

Of special importance are the characteristics of foundation in tailings dam areas. Rocks underlying the entire project area (and containing the various ore bodies) are dominantly very old (Permo-Carboniferous) rocks, carbonaceous shale and dolomitic siltstones, which have been faulted and folding by plate convergence in the Sumatran west coast (Pale green in Figure 3a). According to Middleton 2003 the formation consists of tilted beds with an EW strike and a northerly dip of about 45 degrees with fracturing from brittle tectonic deformation. Inspection of various photos showing recent (2019) road cuts in the Sopokomil valley suggest that the sequence of dipping beds carries down northerly into the hills that flank the valley as shown in my sketch fig 3a.

The eruption of the Toba caldera some 70k years ago flooded the region with hot ash flows (ignimbrite), generally described as the Toba Tuff (pale yellow in Figure 3a). According to Middleton (apparently based on Aldiss et al, 1983) these deposits underlie the Sopokomil valley floor, site of the proposed tailings area. These volcanic deposits are generally taken to be variably cemented ("welded") but reportedly near the surface often take the form of a light ashy deposit which are found in some stream bank deposits according to photographs which I have seen. Aldiss et al describe the shallower tuffs regionally as being air-fall, unwelded, and often fluvially

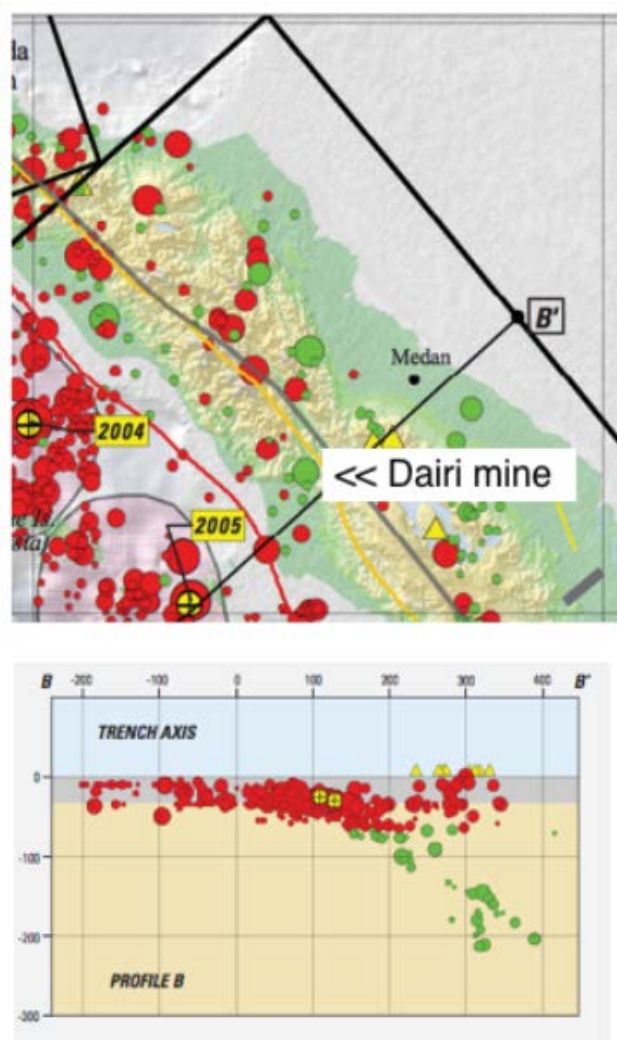
Figure 3. Historical earthquake (Hayes, et al., 2013)

A map and cross section showing historical earthquakes is extracted from a comprehensive summary of seismicity of the area published by the US Geological Survey (Hayes, et al., 2013). This map and many other publications provide comprehensive information on regional seismicity sufficient to evaluate earthquake risk.

The mine is located in one of the world's most active earthquake regions, along the Sumatra subduction megathrust apparently near a triple plate junction which produced in 2004 and 2005 earthquakes of magnitude 9 and 8+ respectively (fig 3). These events rocked buildings as far away as Bangkok and produced intense regional damage including to road embankments and bridge abutments, which are similar in their behavior to tailings dams. Intensity of ground motion produced destruction of facilities at Banda Aceh, which is a comparable distance from the earthquake to the Dairi mine. Japanese investigators (see Sorenson et al., 2007) found that damage was up to about level 6, Japanese JMA scale. This damage category (6.0-6.4) produces these effects:

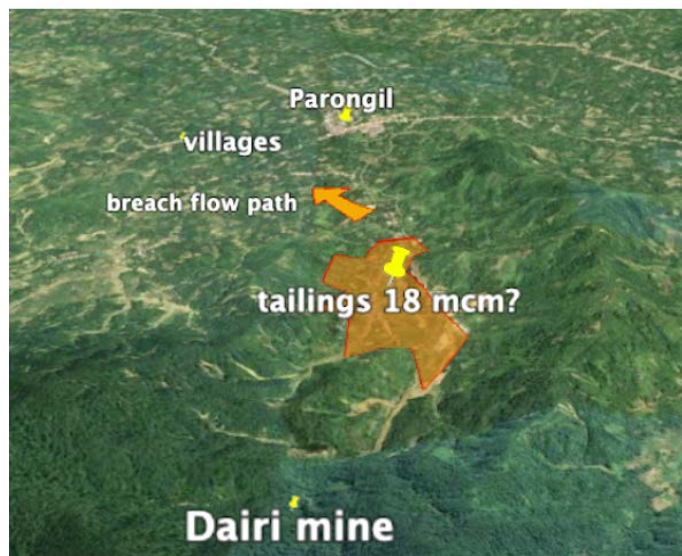
Figure 4. Path of mud wave if a breach occurs.

tailings dam, with a disastrous breach sending a wave of liquid mud downstream to the north.

It has been suggested (Hamilton, oral communication) that the Sopokomil valley and nearby canyon may be the site of an older caldera defined by a circular ridge line which can be seen in figure 4. Such features are often underlain by rhyolite rocks associated with a rising body of extrusive lava. Such rocks are typically fractured and water-bearing.

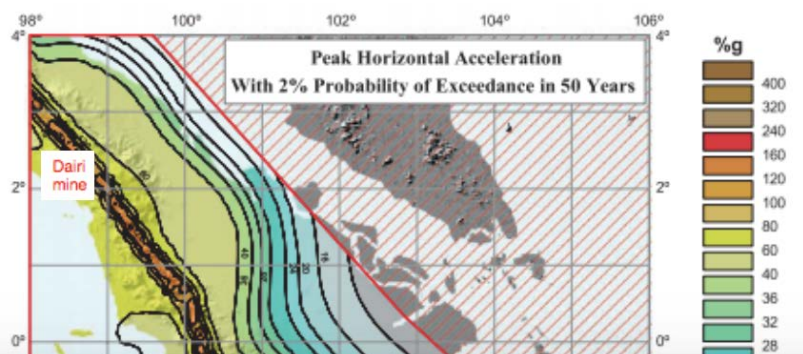
figure 5. Tailings dam very close to Sumatra fault with likely earthquakes up to M 7.5-7.9 and ground accelerations of 100%g

Although the offshore subduction zone mega earthquake poses a threat to long-period structures like tailings deposits, a more dangerous type of earthquake can be expected from the Great Sumatra fault which breaks ground only 15 km to the east of the Dairi site. According to Peterson et al (Ref Petersen et al., 2004) and others this fault is capable of generating earthquakes up to magnitude 7.5 to 7.9 and at this close distance are likely to produce very high ground accelerations on the order of 50-100% gravity (Figure 5).

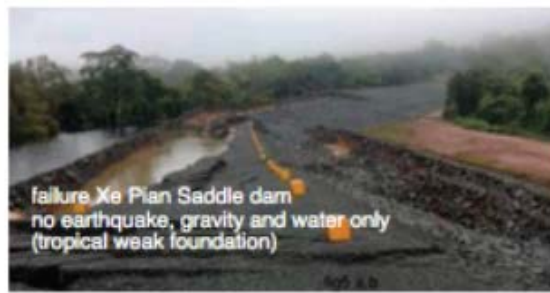
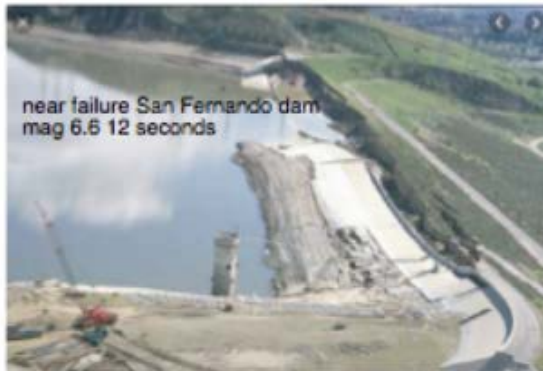
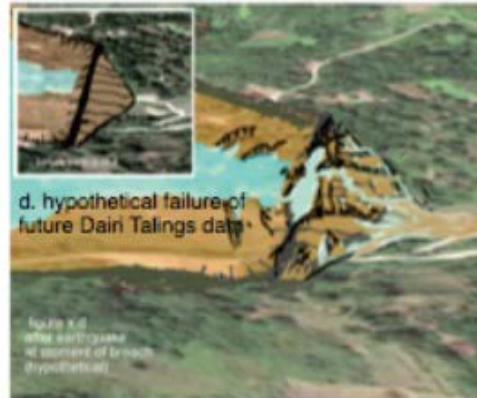
figure 6. a. Failure of Xe Pian dam in Laos 2008; dam breached shortly after this photo with runoff of 500 mcm water flowing 100 km and obliterating 6 villages. No earthquake here, but poorly built dam founded on typical weak leaky tropical soils made dam unable to survive filling of the reservoir b. Near failure of the San Fernando dam in California in a short m 6.6 earthquake. Another few seconds of shaking would have breached this dam with a great death toll. c Analysis by Cai, Wang, et al of a tailings dam in the 2008 Wenchuan earthquake shows that the dam fails in a m=8 earthquake. d. Likely performance of a tailings dam at Dairi mine during a very strong earthquakes, probably from the Great Sumatran fault zone near the site.

As shown in studies of the tailings dam failure at the Wenchuan earthquake in China (Ref Cai et al, figure 6c), embankments, including tailings dams, characteristically concentrate and channel rising earthquake energy toward the crest - so that the destructive intensity may be two or three times greater in the upper part of the tailings compared to at the ground base of the impoundment. It would be extremely difficult and expensive to design a tailings confinement dam that could withstand this level of shaking without cracking and displacement, even assuming the best of all foundation conditions in the valley, an assumption which is not likely to hold true in tropical volcanic terrain.

It is also important to note that over the long term, the next century or more, the dam will be subjected multiple times to these strong earthquakes. These will cause internal displacement within the structure, compromising whatever internal systems are built into it, creating leakage and raising water pressures over time. This threat would not be visible to anyone besides well trained engineers monitoring the safety of the facility with specialized instruments. Even with an expert diagnosis it will be difficult or impossible to repair the damage, especially considering that the earthquakes will come in clusters - main shocks followed by aftershocks (Figure 6d).

Failure of the containment for wet tailings would be most dangerous in the wet season with an abundance of water added to the containment. Cracking and sliding of the retaining structure would initially take on the appearance of the partial failure of the San Fernando dam, figure 6b (Castro et al 2003). But the San Fernando dam was subjected to only a few seconds of strong shaking. Larger earthquake from m 7.5 to 9 would produce shaking that would be much longer in duration with cracks and sliding of many meters in even robustly built dams. This would open the embankment to through flow of water and wet tailings, which would breach the Dairi containment (as in the Baldwin Hills Reservoir shown on video at <https://www.youtube.com/watch?v=c4sm7DdIMkk>) and also the Brazilian Brumadinho Mine.
